## **2026 Nepal rock-ice avalanche, debris flow and flash flood: preliminary assessment**

### **Highlights:**

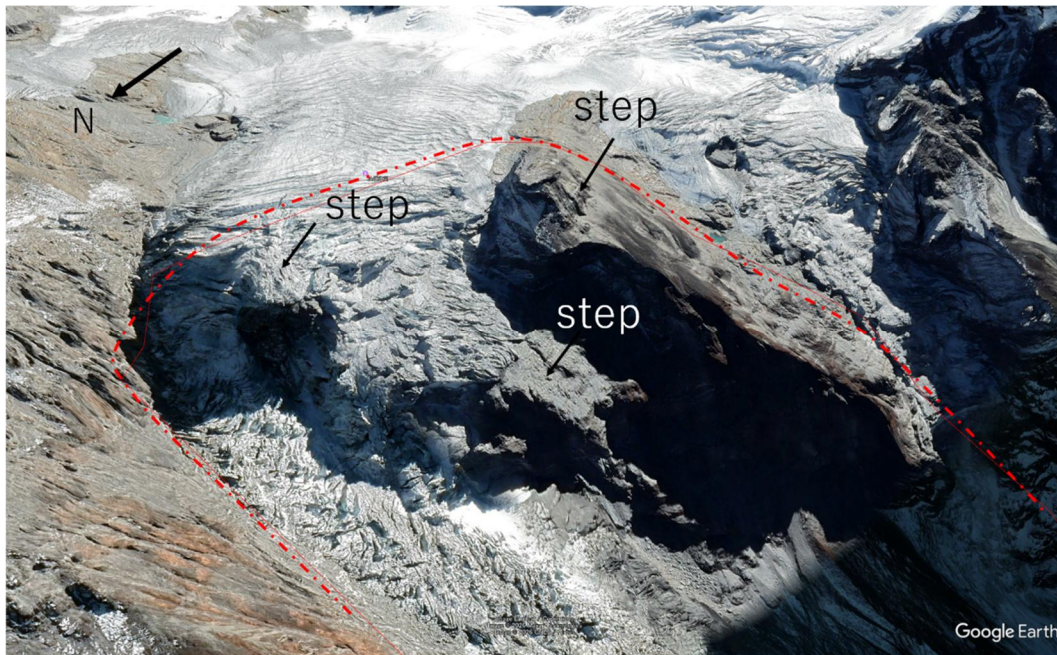
Fig. 3 Topography of the source area prior to the 2026 rock-ice avalanche. The red dashed line indicates the source area the 2026 rock-ice avalanche. (Google Earth imagery acquired on November 28, 2020)

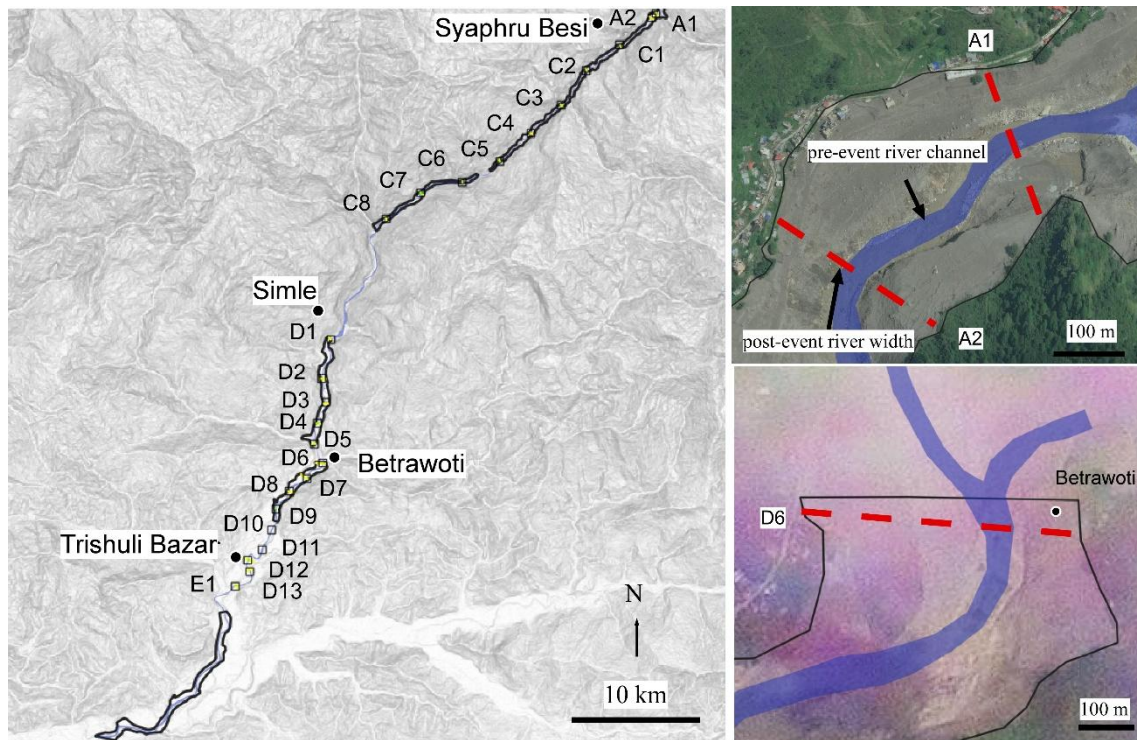
A detailed comparison of pre- and post-event channel conditions along an approximately 40-km reach of the Trishuli River, from Syaphru Besi (approximately 1,430 m a.s.l.) to Trishuli (approximately 530–540 m a.s.l.) (Fig. 7), further demonstrates the magnitude of these geomorphic changes. Channel widths increased at all measured locations, with an average increase of approximately 4.5 times compared with pre-event conditions (Table 1). The magnitude of widening varied considerably among locations, reflecting differences in valley morphology and the availability of sediment for erosion and deposition.

Fig. 7. Locations of cross sections used to measure changes in channel width along the Trishuli River between Syaphru Besi and Trishuli Bazar before and after the 2026 disaster. Results are summarized in Table 1.
