## **2026 Nepal rock-ice avalanche, debris flow and flash flood: preliminary assessment**

### **Highlights:**

### **1. Overview**

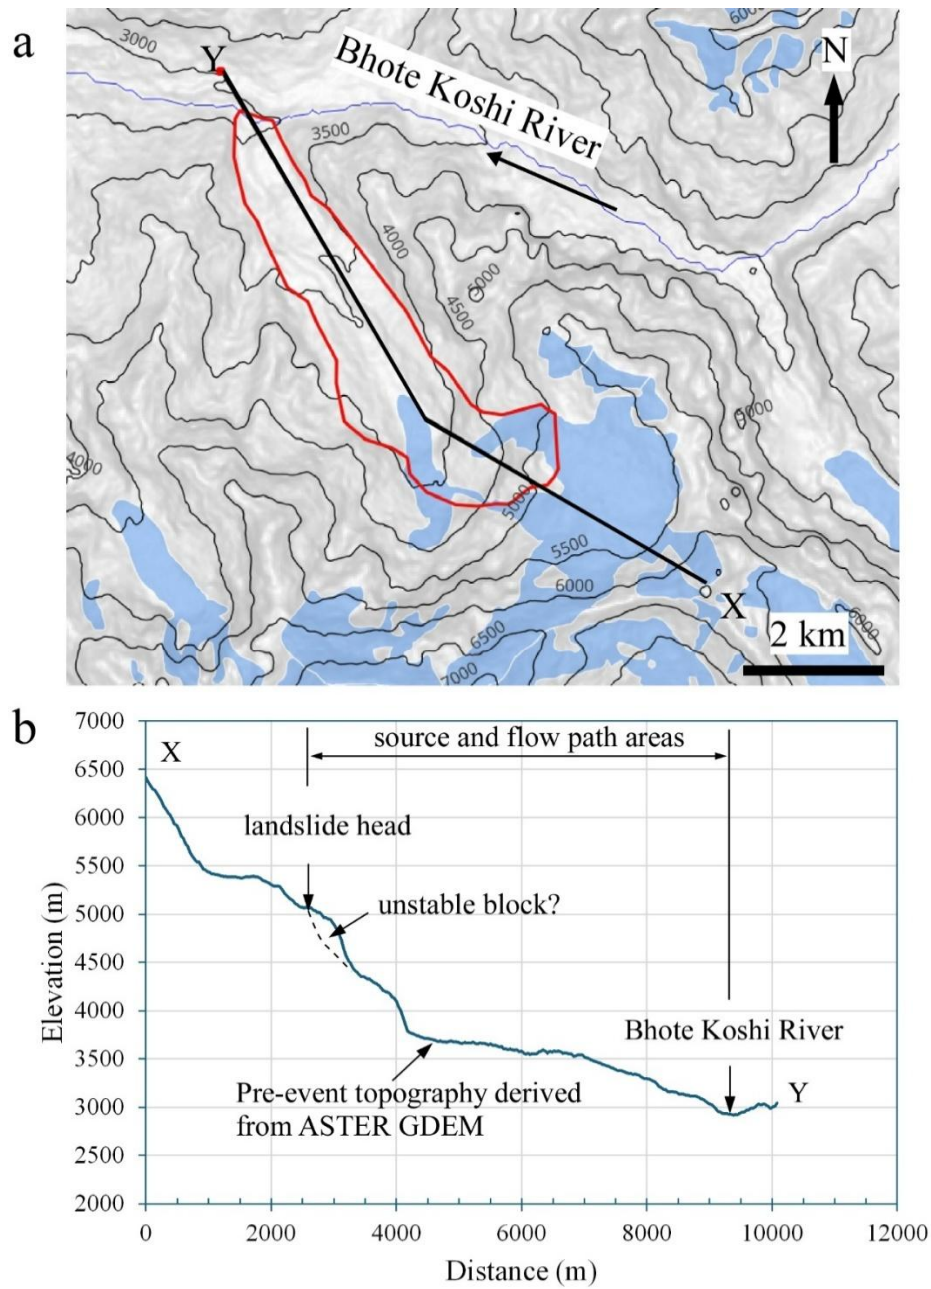
The source area is located at the terminus of a glacier at an elevation of approximately 5,060 m a.s.l., on a steep, high-relief mountain slope comprising glacier ice and underlying bedrock (Fig. 1). The source area has a maximum width of approximately 1.8 km and, together with the initial flow path, covers approximately 7.8 km<sup>2</sup>. The area is characterized by high relief, steep slopes, and a narrow, confined valley system (Fig. 1).

Fig. 1 Pre-event topography and longitudinal profile of the 2026 rock-ice avalanche source area and flow path. (a) Topographic map showing the landslide source and initial flow-path areas (red polygon). The black line from X to Y indicates the transect used to construct the longitudinal profile. Blue polygons indicate the distribution of glacierized areas based on Pfeffer et al. (2014). Contour lines and the underlying slope image were derived from the ASTER Global Digital Elevation Model (GDEM). (b) Longitudinal elevation profile along the X–Y transect, showing the landslide head and inferred unstable block.

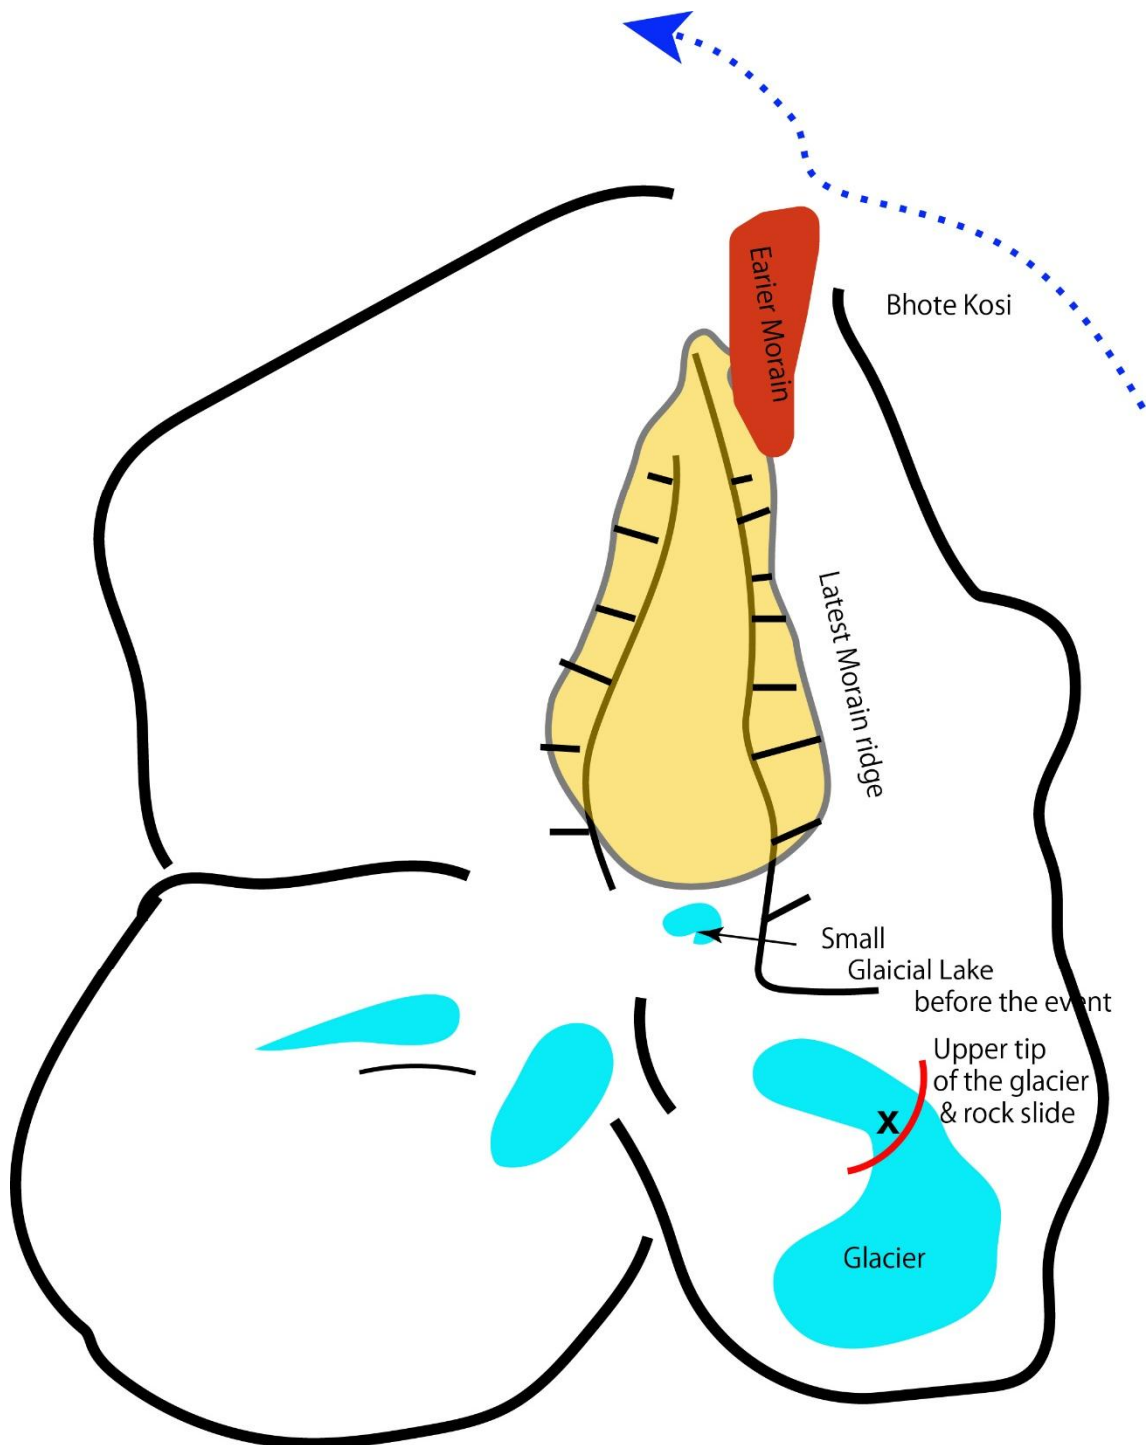
Examination of pre-event Google Earth imagery suggests that a small, shallow glacial lake was present near the lower terminus of the glacier (Figs. 1a and 2). Downstream of the lake, an apron-like accumulation surface composed of moraine and till extended toward the main Bhote Koshi River valley. Step-like features, possibly associated with differential glacier movement or localized deformation, were visible near the glacier terminus (Fig. 3). In addition, small step-like features were observed on exposed bedrock slabs immediately below the glacier terminus. Although their origin cannot be determined conclusively from satellite imagery alone, these features may

Fig. 2 Pre-event Google Earth imagery of the source area and flow path of the 2026 rock-ice avalanche. The schematic illustration is not drawn to scale.

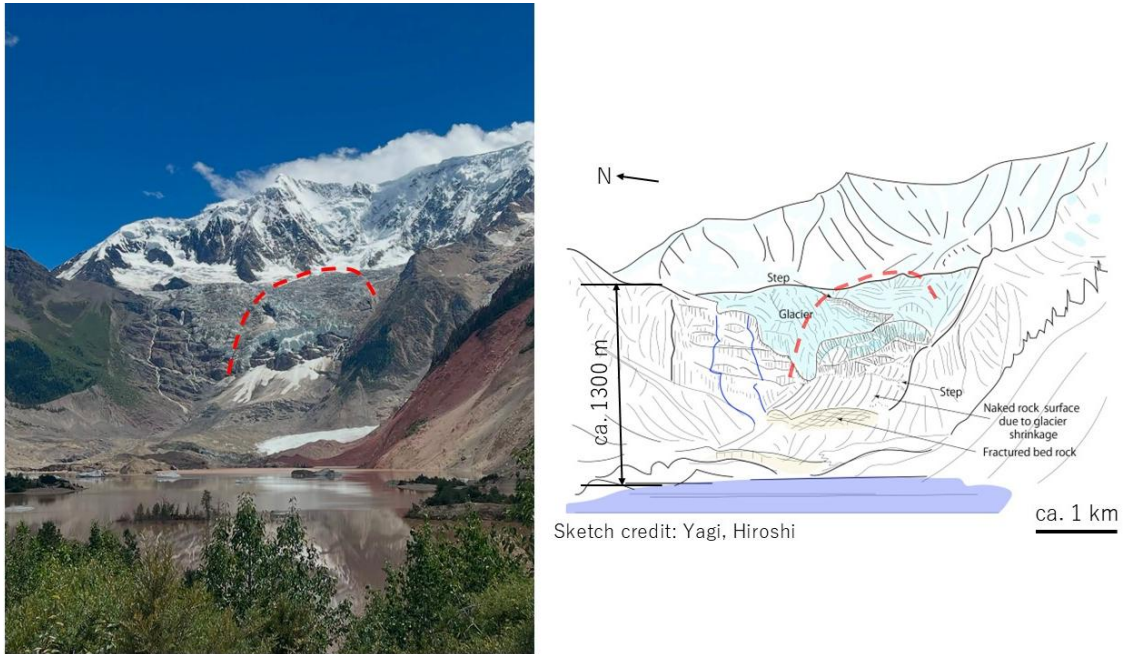
Fig. 3 Topography of the source area prior to the 2026 rock-ice avalanche. The photograph on the left, taken on 18 August 2026, was obtained from a Facebook post ([https://www.facebook.com/photo?fbid=10165907469081617&set=pb.693976616.-2207520000&locale=ja\\_JP](https://www.facebook.com/photo?fbid=10165907469081617&set=pb.693976616.-2207520000&locale=ja_JP)). The red dashed line indicates the source area the 2026 rock-ice avalanche. The sketch on the right was prepared by Hiroshi Yagi based on the photograph.

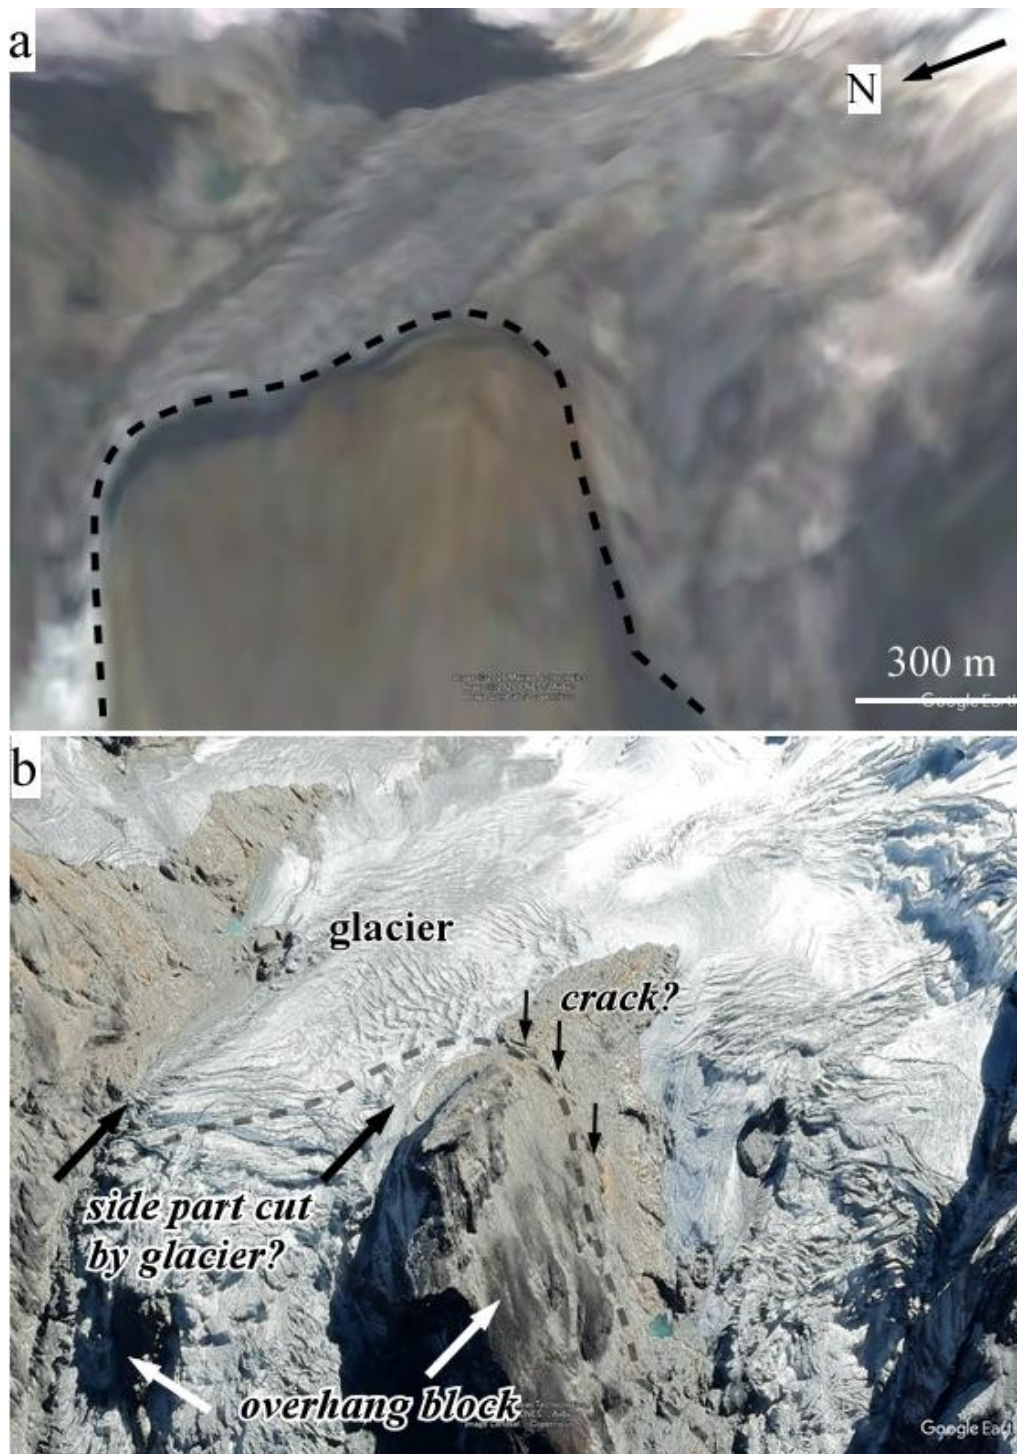
The source area is further characterized by complex bedrock morphology and structural discontinuities. Two underlying rock blocks appear to form an overhanging structure, with their lateral margins apparently undercut by glacial erosion (Fig. 4). Such undercutting may have reduced the lateral and basal support of the rock mass. In addition, the exposed bedrock contains continuous and persistent fractures (Fig. 5), indicating the presence of pre-existing structural discontinuities within the slope. The exposed bedrock surfaces are not uniformly smooth and strongly polished, as might be expected from simple glacial abrasion, but instead are characterized by fractured and irregular surfaces. This morphology suggests that, in addition to glacial abrasion and localized plucking, structural controls such as joints and bedding planes, together with frost weathering under periglacial climate, may have contributed to the progressive weakening and disintegration of the rock mass.

Fig. 4 Close-up views of the source area before and after the event. (a) Landsat 9 satellite imagery acquired after the event, obtained from Soar (<https://soaratlas.com/>). (b) Google Earth imagery acquired on December 1, 2017, showing the pre-event condition. The dashed black line indicates the landslide extent.

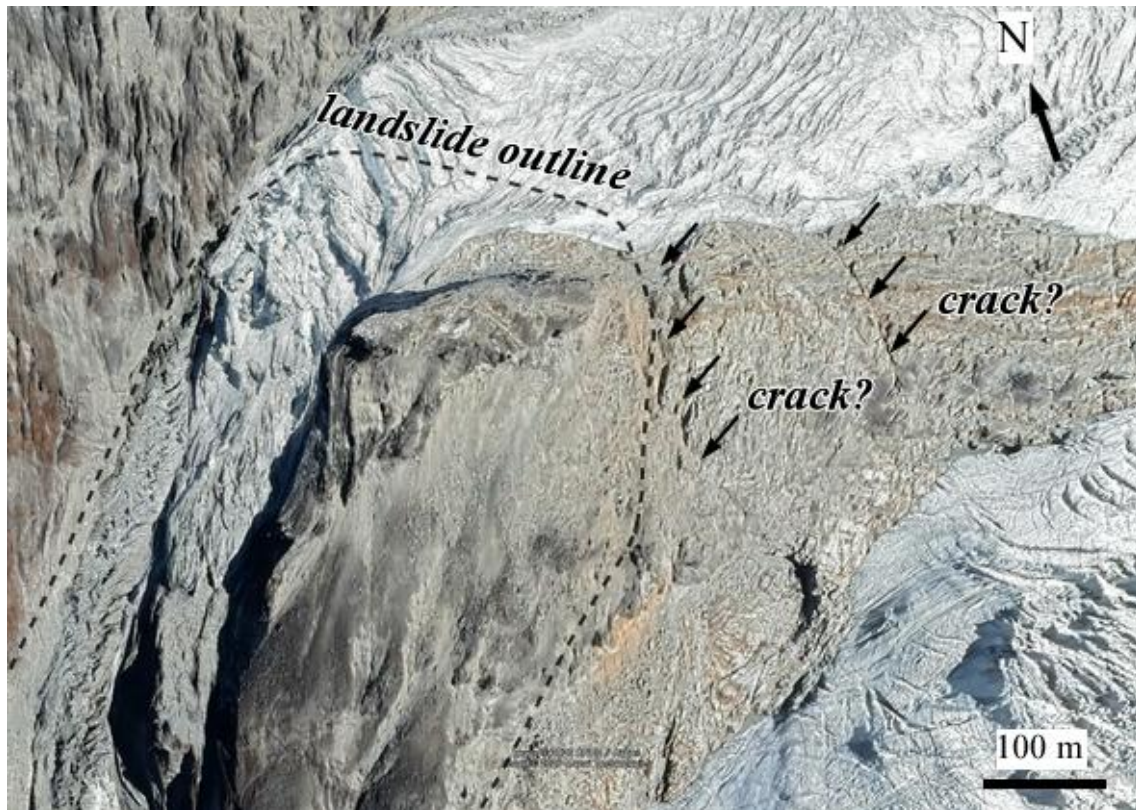
These pre-existing discontinuities may also have facilitated the infiltration of snowmelt and glacier meltwater into the slope, promoting water penetration and progressive weakening along fractures and bedding planes. The brownish coloration observed along some fractures (Fig. 5) may indicate oxidation associated with water–rock interactions, although this interpretation requires further verification.

Fig. 5 Close-up view (Google Earth imagery acquired on December 1, 2017) of the source area before the event. The exposed underlying bedrock appears to contain continuous or persistent cracks, along which rock color changed to brownish suggesting the intense weathering occurred.

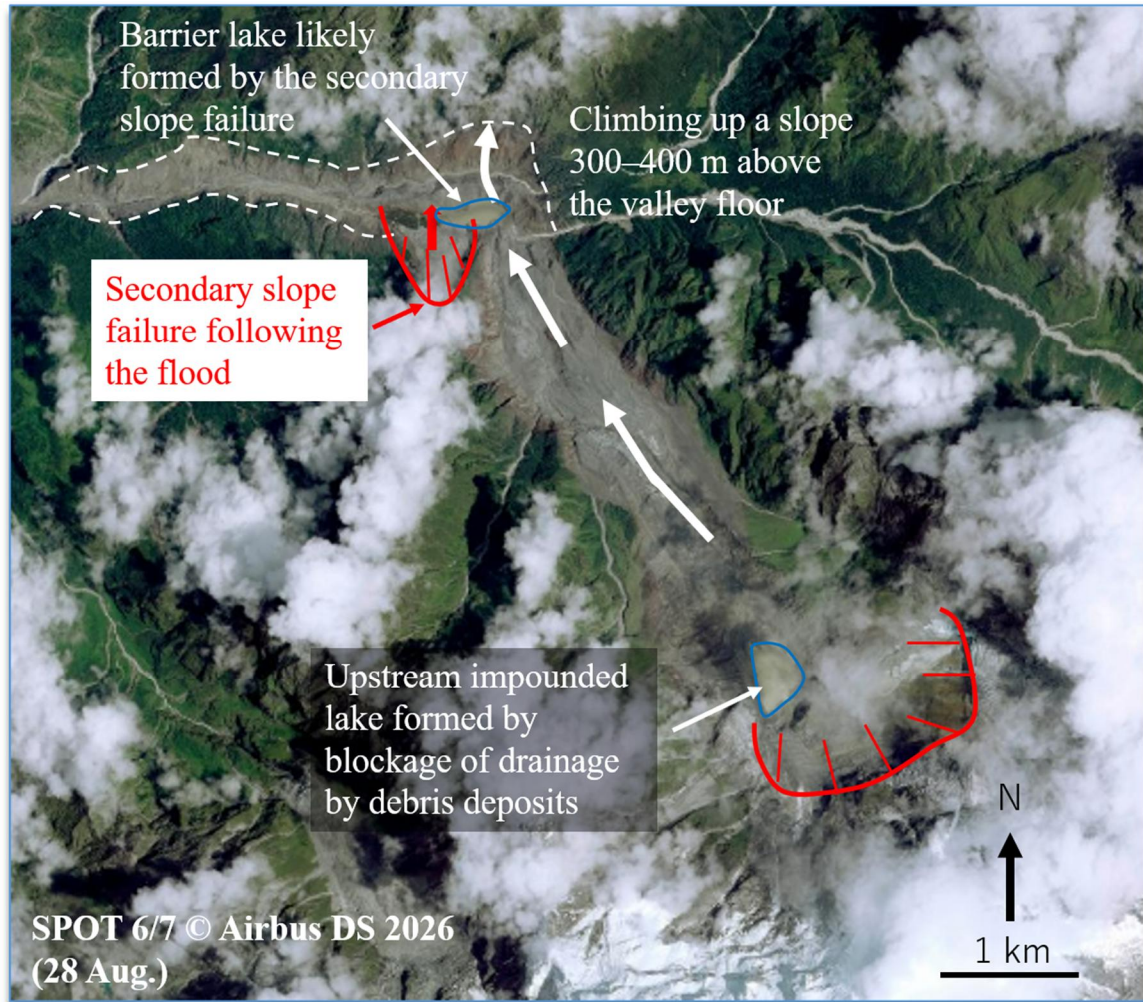
Two impounded lakes subsequently formed immediately downstream of the failure source and near the confluence between the U-shaped valley and the V-shaped valley of the Bhote Koshi River (Fig. 6). These lakes were not observed immediately after the initial failure. Based on satellite imagery acquired on 28 August, the upstream impounded lake was approximately 600 m long and 400 m wide, with an area of approximately 190,000 m<sup>2</sup>. The downstream lake was approximately 900 m long and 260 m wide, with an area of approximately 120,000 m<sup>2</sup>.

Near the confluence between the U-shaped and V-shaped valleys, a moraine-like landform, which is presumed to be connected to the older moraine, separates the main river from its tributary. This feature forms an east–west-oriented ridge, with a relative height of approximately 150 m above the valley floor of the main river and a maximum width of approximately 300 m. The flow originating from the failure source appears to have travelled northward and overtopped this ridge-like moraine. It subsequently reached the upper part of the opposite northern valley slope, approximately 300–400 m above the valley floor (Fig. 6). These observations further demonstrate the exceptional mobility and run-up height of the flow.

A large secondary landslide, covering an area of more than 340,000 m<sup>2</sup>, was identified on the western side of the confluence (Fig. 6). Satellite imagery acquired on 27 August shows that the slope was still covered by vegetation and no landslide scar was visible. In contrast, imagery acquired on 28 August clearly shows a newly developed landslide scar, indicating that the failure occurred between 27 and 28 August. This temporal sequence suggests that the landslide was not directly formed during the initial upstream failure on 26 August. Instead, it may represent a secondary slope failure caused by progressive destabilization following the passage of the flood and debris flow. Substantial erosion at the base of the mountain slope during the 26 August event may have undercut and weakened the slope, leading to subsequent failure on the right bank between 27 and 28 August.

The large volume of sediment generated by this secondary landslide may then have partially or completely blocked the main river, contributing to the formation of the downstream impounded lake. This sequence represents an additional cascading process in which the initial glacier–bedrock failure triggered a high-energy sediment-laden flow,

Fig. 6 Formation of upstream and downstream impounded lakes and the occurrence of a secondary slope failure following the 2026 disaster. The satellite image was acquired on 28 August 2026 and downloaded from Airbus Intelligence (<https://space-solutions.airbus.com/>).

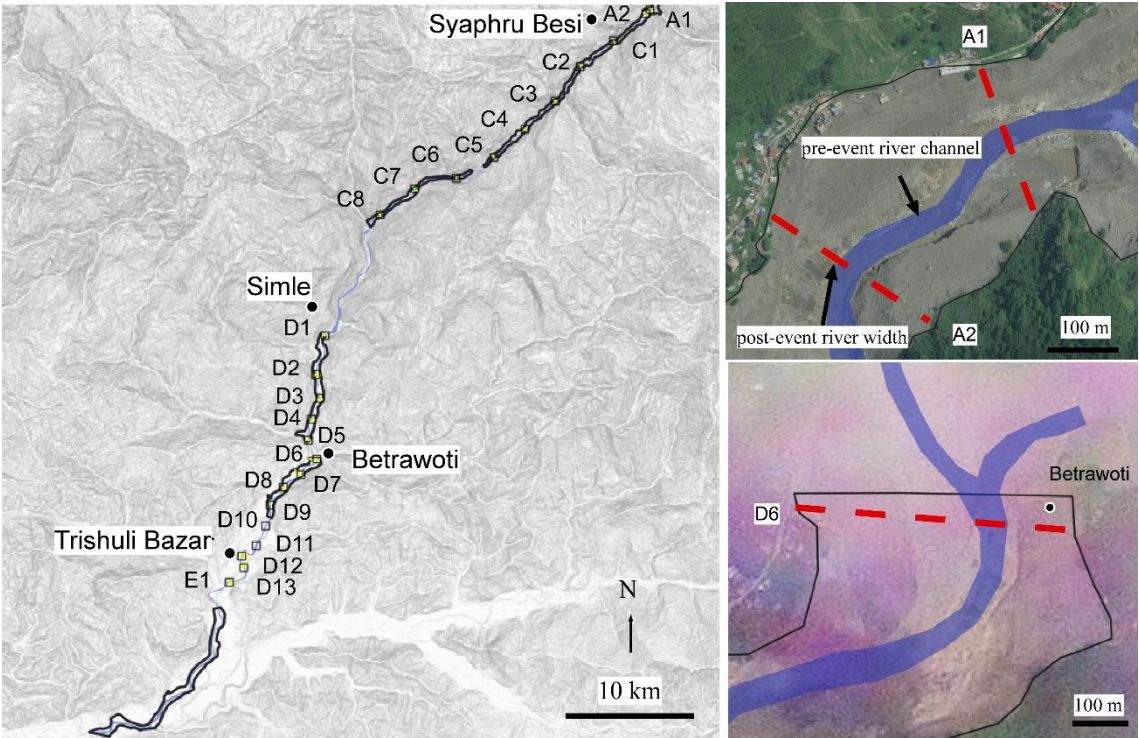
A detailed comparison of pre- and post-event channel conditions along an approximately 40-km reach of the Trishuli River, from Syaphru Besi (approximately 1,430 m a.s.l.) to Trishuli (approximately 530–540 m a.s.l.) (Fig. 7), further demonstrates the magnitude of these geomorphic changes. Channel widths increased at all measured locations, with an average increase of approximately 4.5 times compared with pre-event conditions (Table 1). The magnitude of widening varied considerably among locations, reflecting differences in valley morphology and the availability of sediment for erosion and deposition.

Fig. 7. Locations of cross sections used to measure changes in channel width along the Trishuli River between Syaphru Besi and Trishuli Bazar before and after the 2026 disaster. Results are summarized in Table 1.

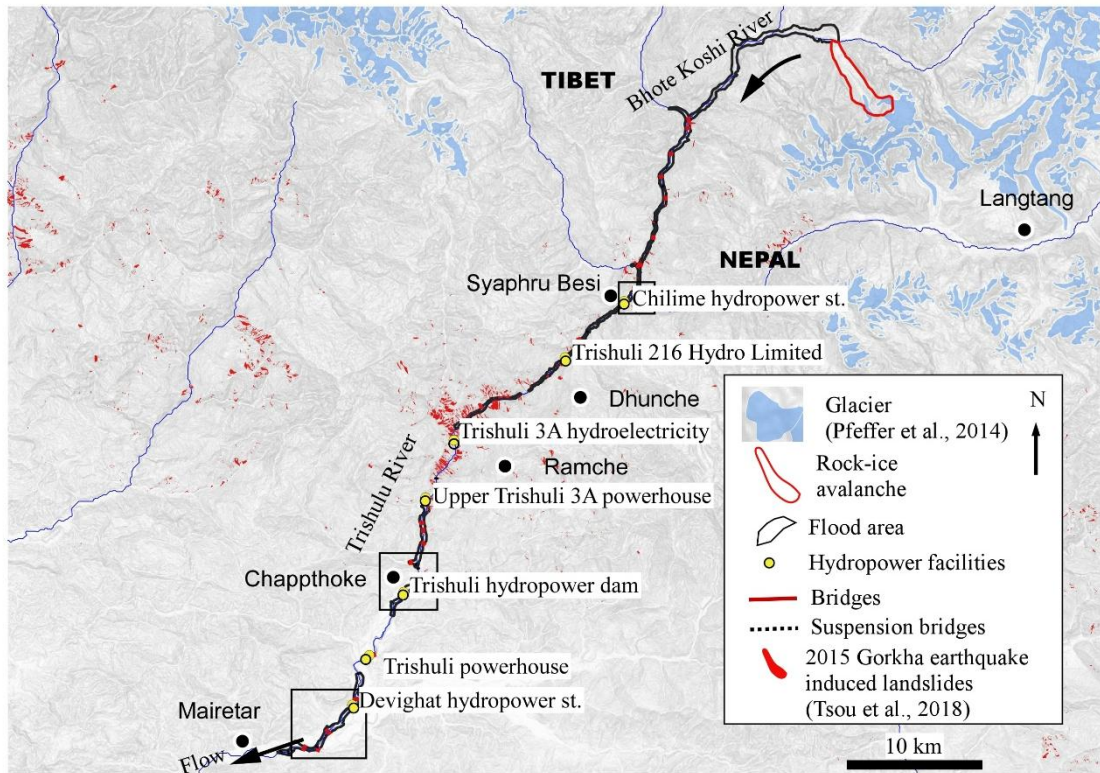
The extensive geomorphic changes caused severe damage to settlements and infrastructure. The expansion of the active river corridor affected adjacent settlements, agricultural land, roads, bridges, and hydropower facilities (Figs. 8 and 9). Based on satellite imagery, at least 2,587 buildings, 21 bridges, 12 suspension bridges, and 7 hydropower facilities were identified as destroyed. Although road damage was not systematically included in the present mapping, widespread disruption of the road network was evident from the available satellite imagery. Between the Trishuli 3A Hydroelectric Project and Syaphru Besi, a road is located on a relatively high surface along the left bank of the Trishuli River. In contrast, roads closer to the river channel, particularly between Syaphru Besi and the Trishuli 3A intake structure, appear to have been constructed along the lower part of the valley flank following the 2015 Gorkha earthquake.

Fig. 8 Distribution of areas affected by the rock-ice avalanche and subsequent debris flow and flash flood, including damaged infrastructure. Blue polygons indicate the distribution of glacierized areas based on Pfeffer et al. (2014). The underlying slope map was derived from the ASTER Globe GDEM. The interpretation is subject to uncertainty owing to the spatial resolution of the available satellite imagery and cloud cover, which may have obscured some affected areas. Furthermore, areas downstream of Mairetar were excluded from the analysis because of limited satellite data availability. Squares indicate areas shown in greater detail in Fig. 9 from upstream to downstream.

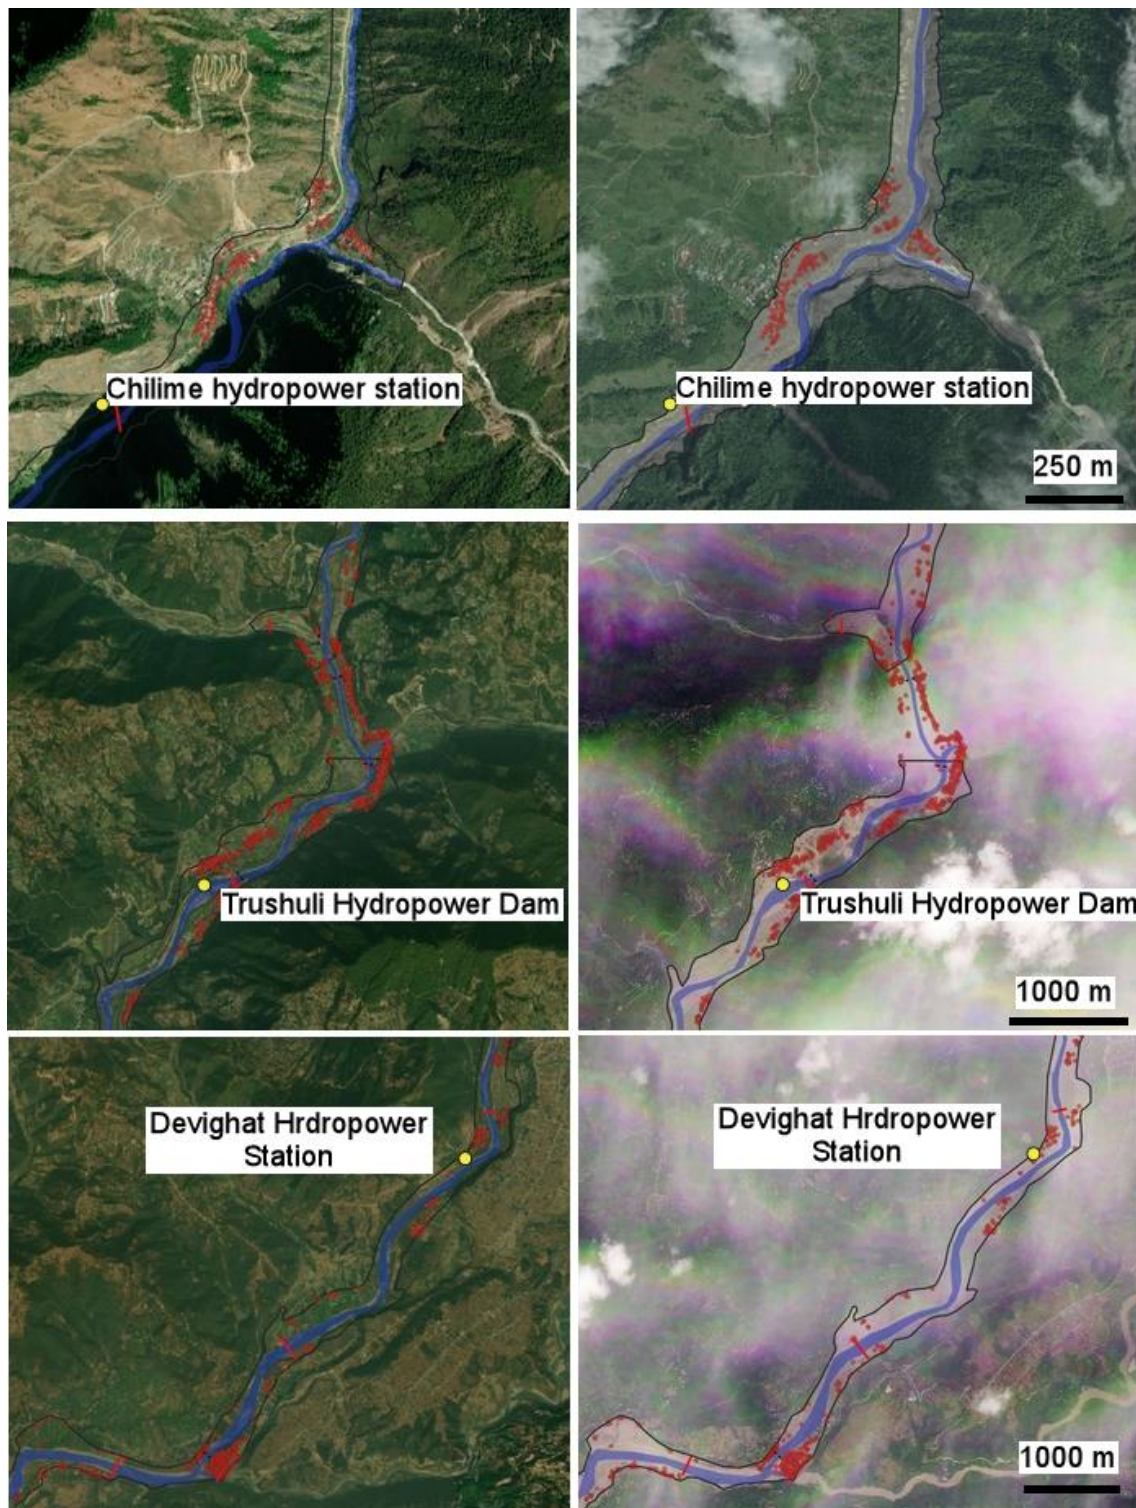
Fig. 9 Close-up satellite images of the affected areas before (left panels) and after (right panels) the event. Pre-event imagery consisted of satellite images from Microsoft Bing, whereas post-event imagery acquired on August 27, 2026, consisted of Planet imagery obtained through OpenAerialMap (<https://map.openaerialmap.org>). Red points indicate

the locations of destroyed buildings. Blue polygons indicate the river channel before the event. Other symbols and legends are the same as those in Fig. 8
